Technical Developments for the Inspection of Off-shore Wind Blades: Final Report

NOWRDC #126 Report Deliverables for 4.1

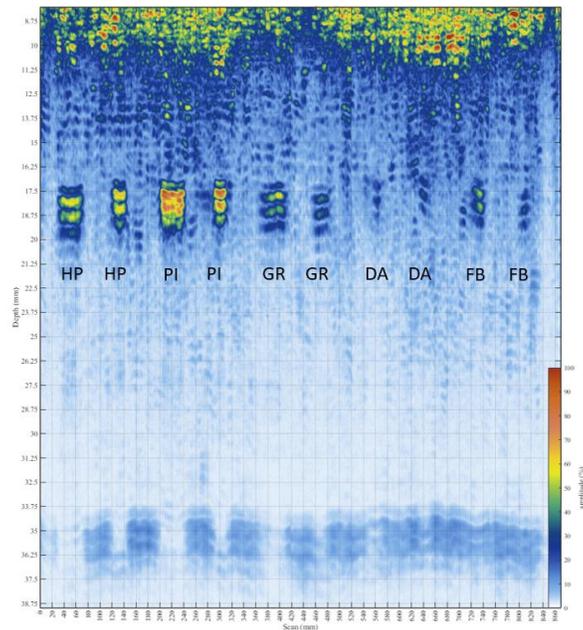
Figure 3-7. Cumulated PWI/TFM side view of “REF-STD-C3-141-SNL”, scanned longitudinally by the 5MHz array to cover the features at the depth of 17.5mm. Feature indications are labelled by flaw type. Note that the axis scales are not equal.

In the longitudinal scans, all defect types were successfully detected with SNR of 6dB or higher, except for dry areas. In transverse scans, most defect types were successfully detected with SNR of 6dB or higher, though many of the flaws that were closest to the top surface had a SNR lower than 6dB due to poorer ability to focus within the near field of the array. The greases and fuzz balls were also difficult to detect strongly at greater depths.

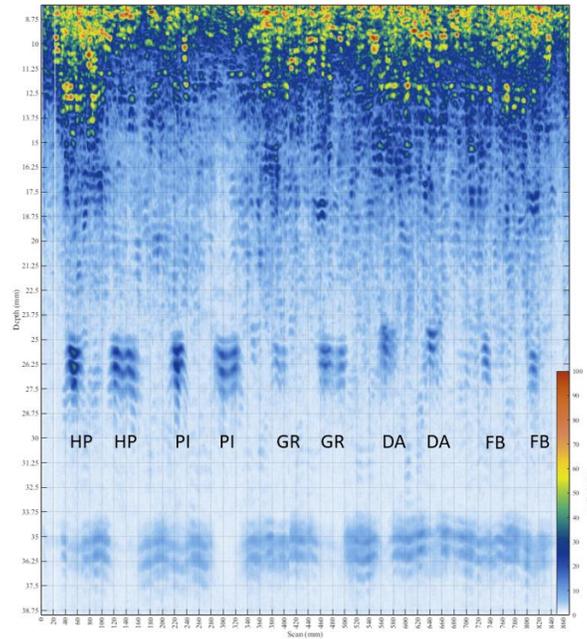
Figure 3-8. Cumulated PWI/TFM side view of “REF-STD-C3-141-SNL”, scanned longitudinally by the 5MHz array to cover the features at the depth of 26.3mm.

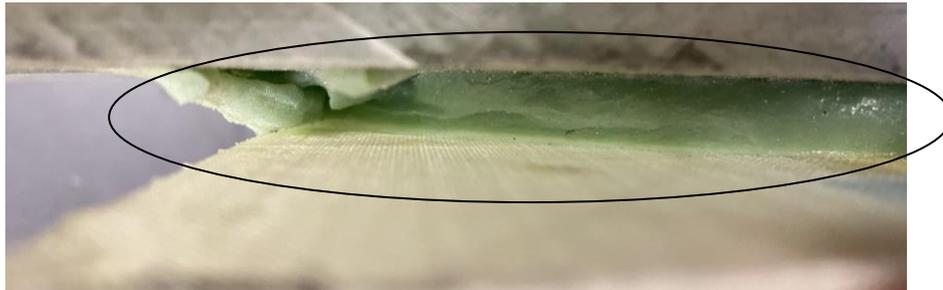
Looking at the inspection result, the area of the spar cap that is bonded underneath the top surface of the part can be identified. The small area at the top left corner of the bond area and the region spanning the width (circled in red) indicates dis-bonds in the adhesive area. The presence of a dis-bond in the upper left region was confirmed visually, and a photograph taken of the region, is shown in Figure 3-16. It is a small region of missing adhesive underneath the fiberglass upper layer.

Figure 3-9. WIND-7-110-SPAR-150. Missing adhesive underneath the fiberglass piece.

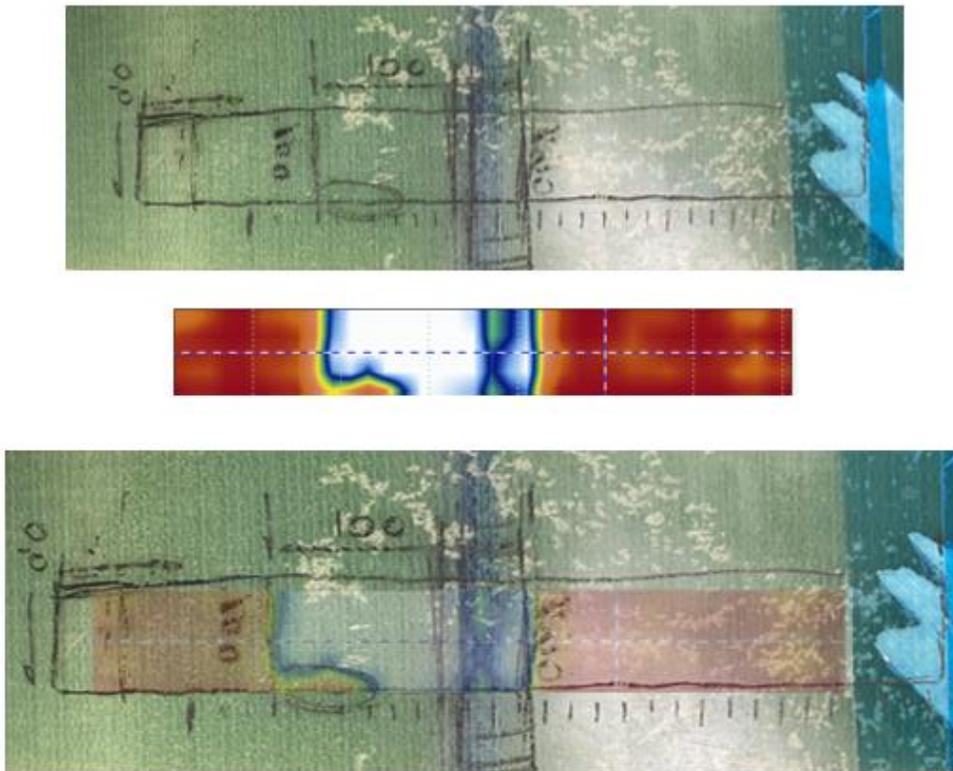
The second disbond could not be confirmed because it is not visible in the part. It is located directly between the upper portion and the adhesive but above the spar cap. The locations of the flaws are overlaid on images of the WIND-7-110-SPAR-150 in Figure 3-17.

Figure 3-10. Sample WIND-7-110-SPAR-150. Photograph of the top of the sample (top), C-scan data of the inspection with MAPS (middle), and data overlaid on top of photograph (bottom).

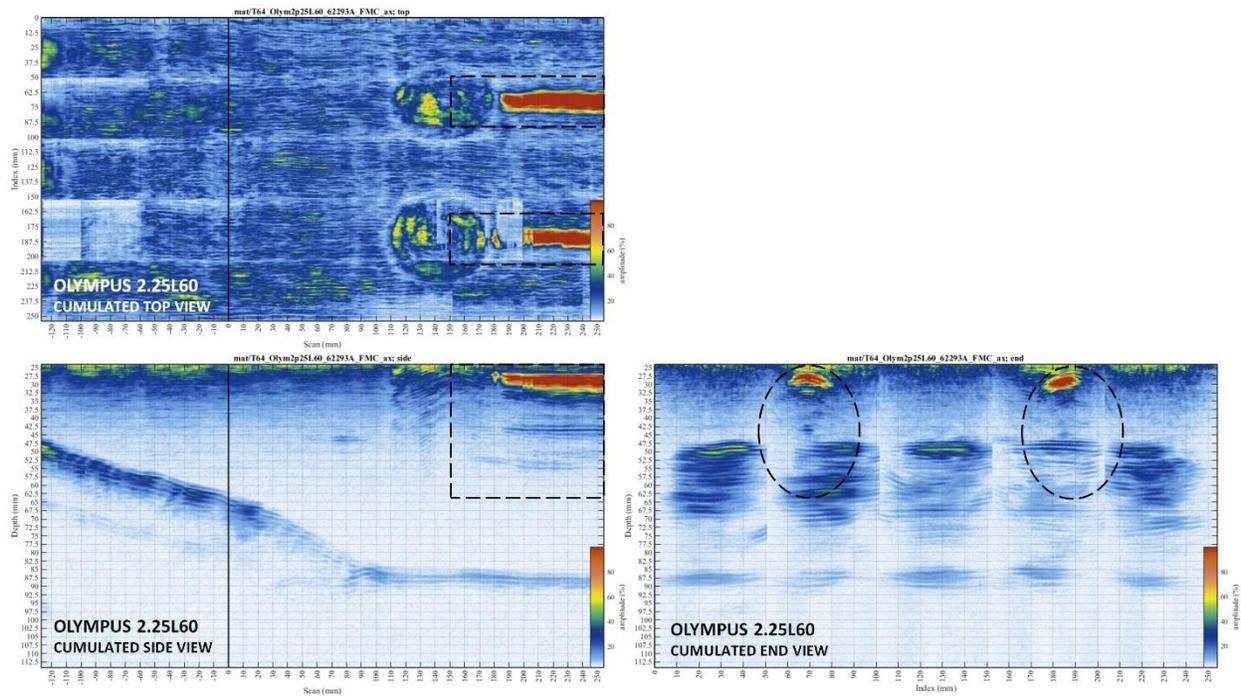
Figure 7-2. Compositing view of volumetric TFM data acquired from axial scan of Section #2, showing (a) top view; (b) side view and (c) end view

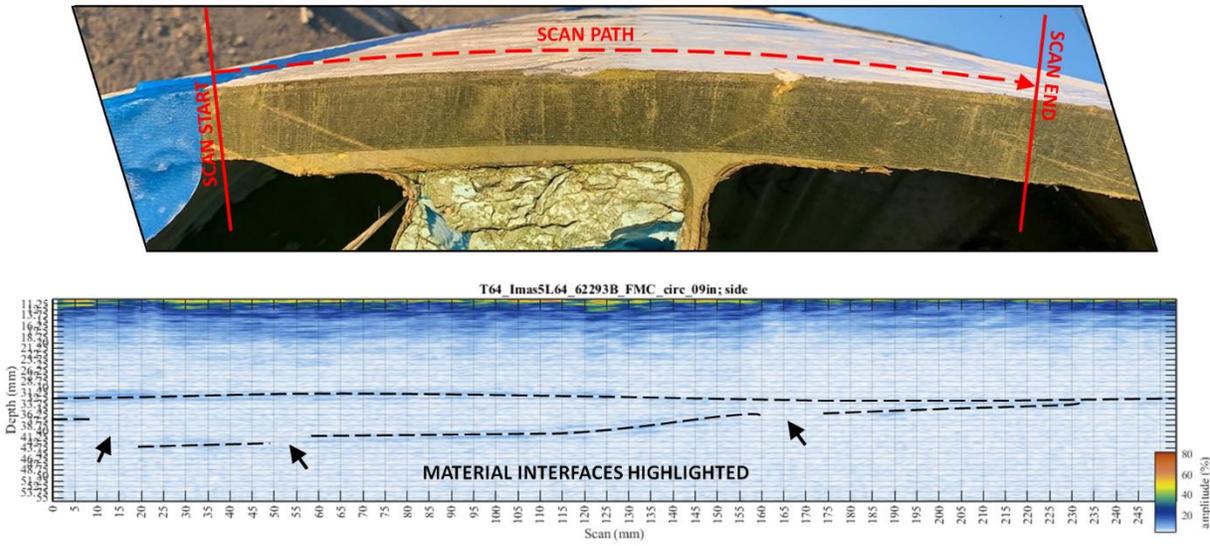
Figure 7-3. (a) Photograph from the end of Section #4 and (b) a corresponding annotated side view of volumetric TFM data captured by the 5MHz Imasonic probe

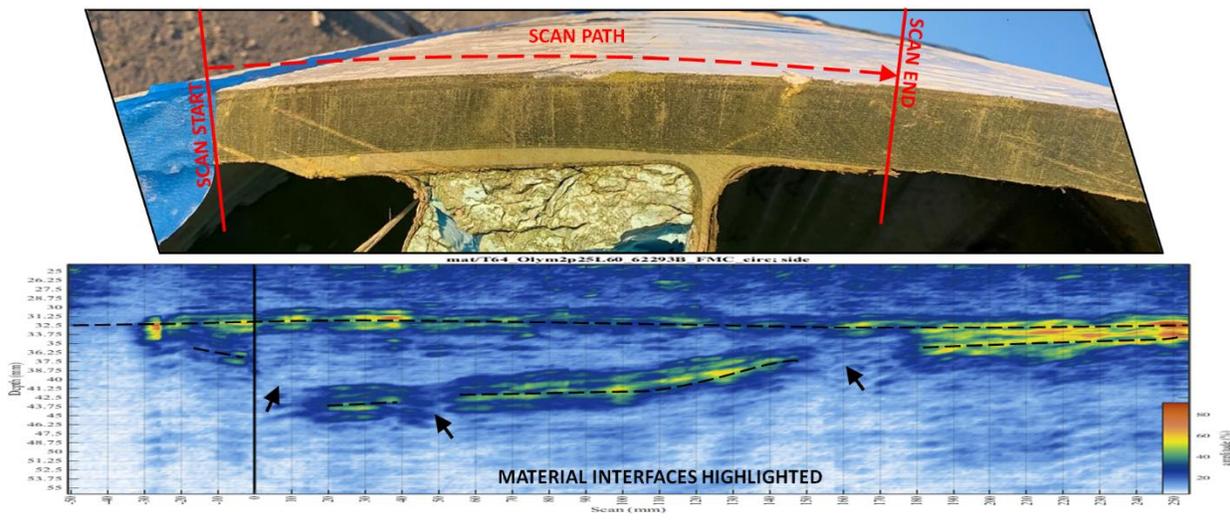
Figure 7-4. (a) Photograph from the end of Section #4 and (b) a corresponding annotated side view of volumetric TFM data captured by the 2.25MHz Olympus probe

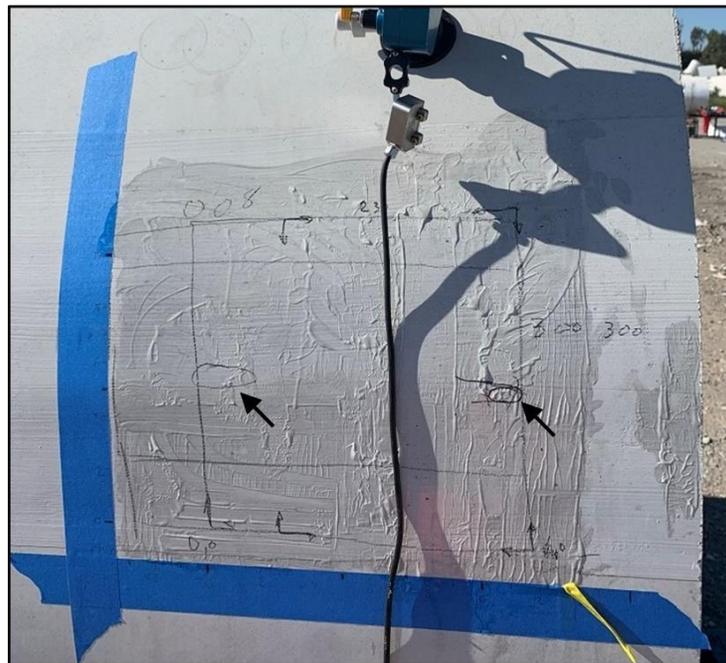
Figure 7-5. Scanning area at the OD of Section #7. Suspected reflectors of interest are indicated by the two black arrows

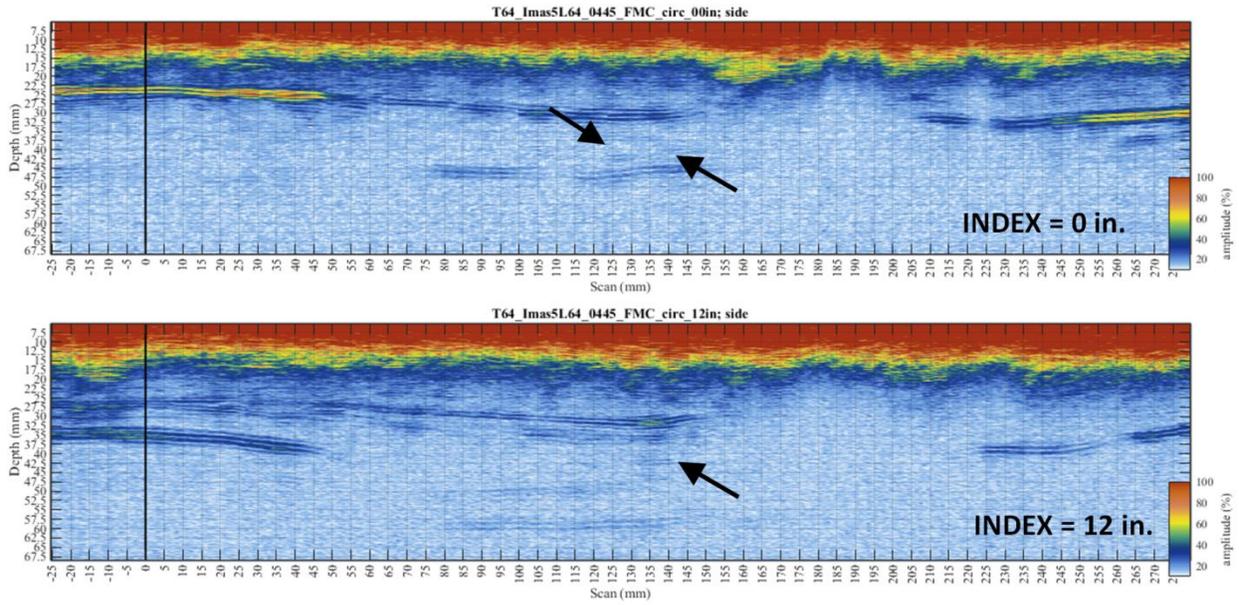
Figure 7-6. Side views at (a) index=0.0in. and (b) index=12.0in., which slice the scan volume so at the locations of suspected reflectors of interest indicated in

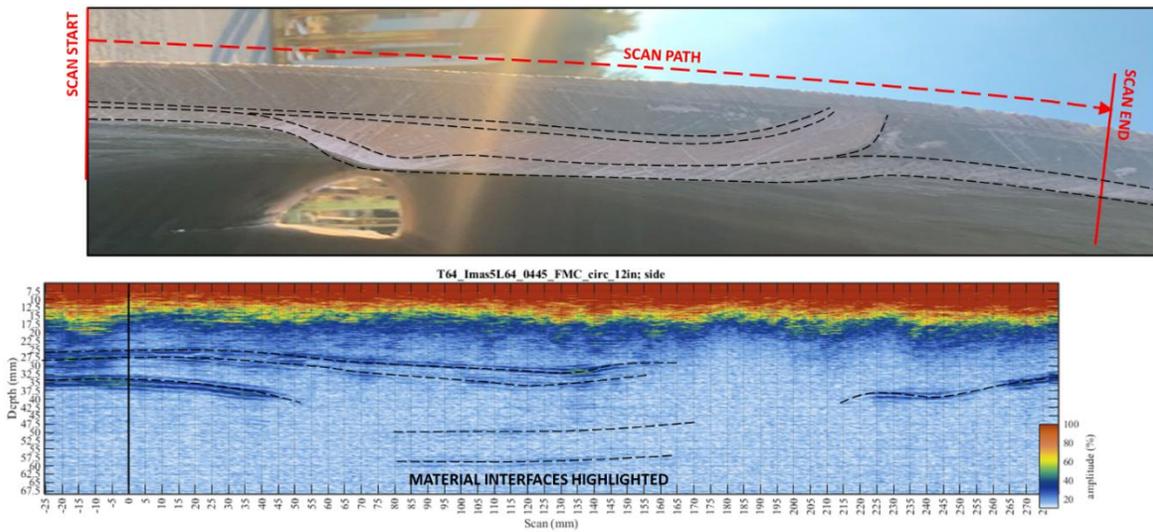
Figure 7-7. (a) Photograph from the end of Section #7 and (b) a corresponding annotated side view of volumetric TFM data captured by the Imasonic 5MHz probe

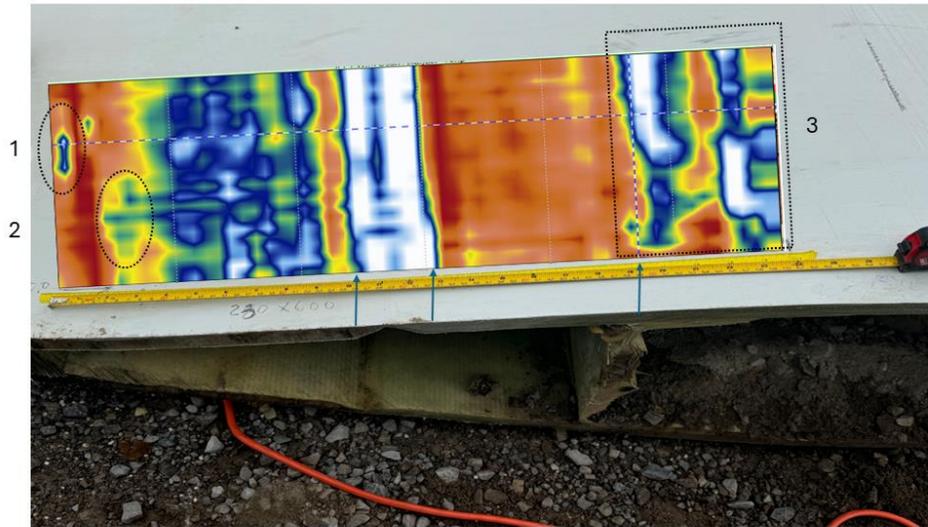
Figure 7-23. AMWI Microwave Inspection image overlay on part showing flaw location

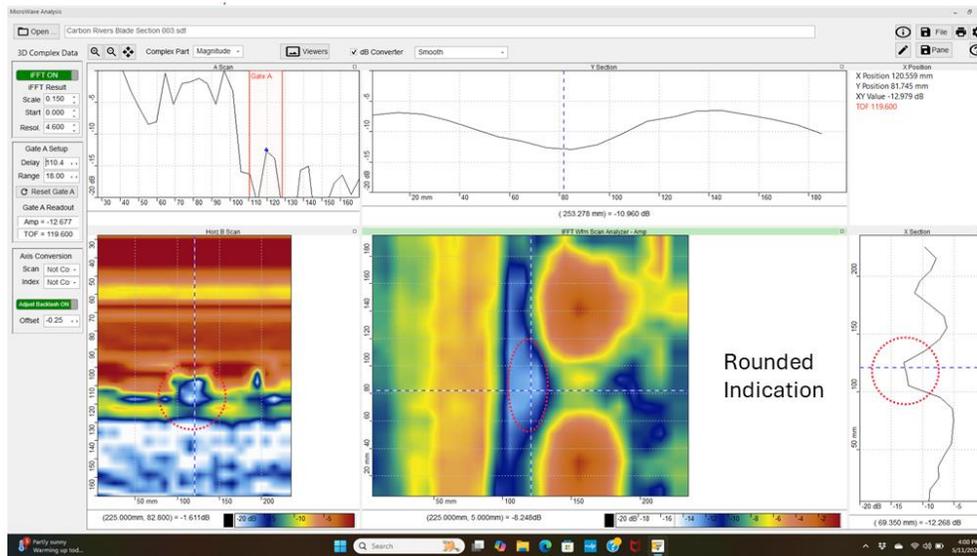
Figure 7-308. Root section with rounded indication

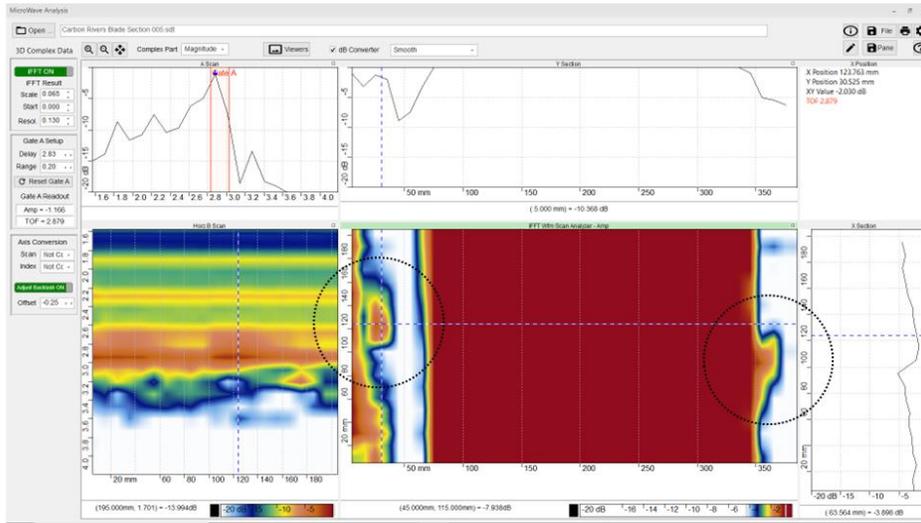
Two bond line indications at edge of CFRP to GFRP

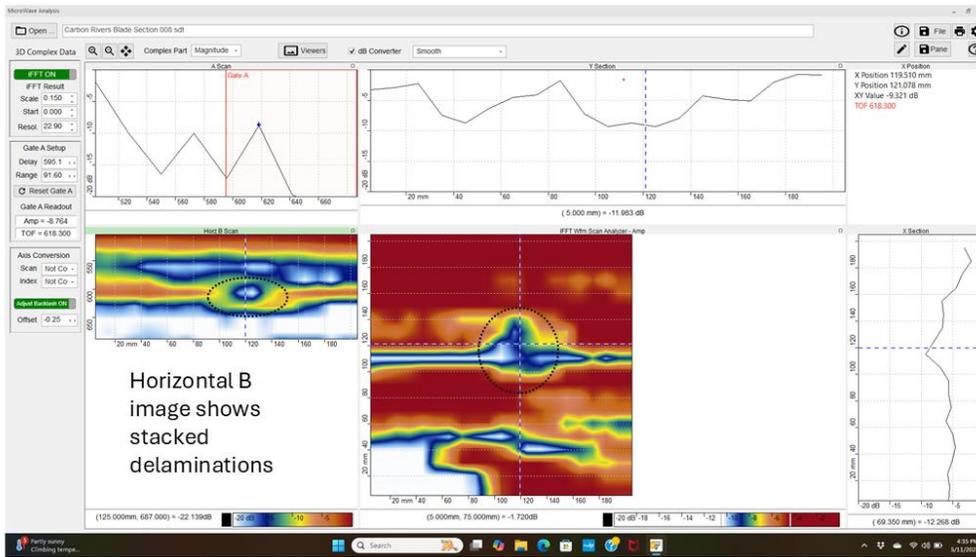
Figure 7-40. Horizontal B image shows ability to detect and locate stacked flaws within part

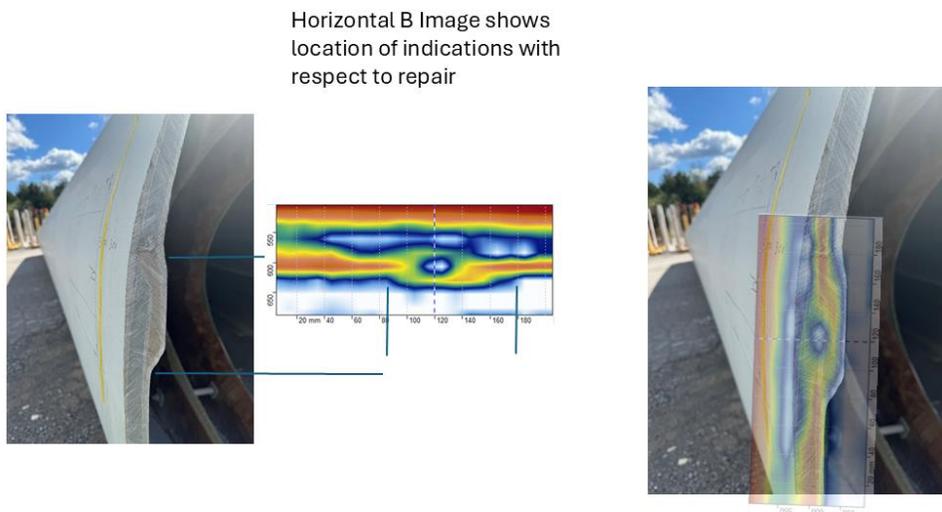
Figure 7-41. Horizontal B image compared to part edge to validate ability for microwave imaging to track varying blade wall thickness in the presence of delamination
