Project 118: Final Final Report

Quarter Scale Testing of the Intelligent Mooring System for Floating Offshore Wind Platforms

The National Offshore Wind Research and Development Consortium

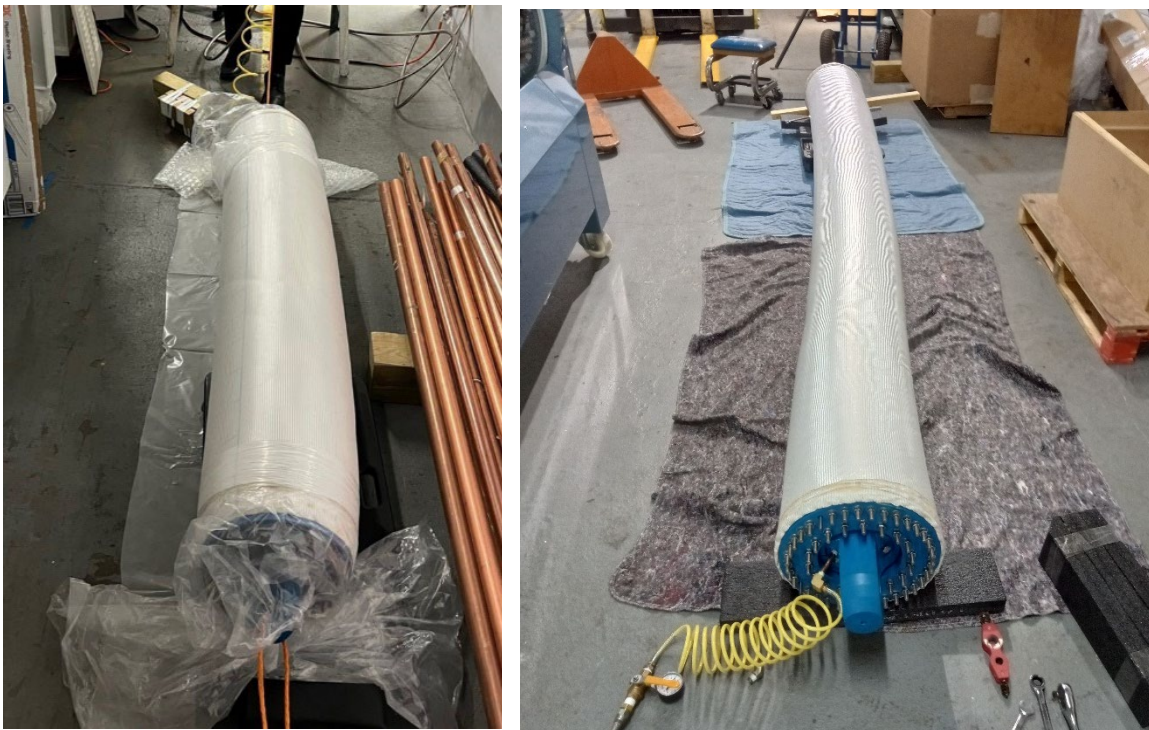
Figure 1. 2m and 4m IMS Test Devices

The quarter-scale test was conducted on two IMS units attached in series and experiencing the same tension. An IMS functions as a pneumatic spring, with an internal bladder housed within a double-braided Dyneema sleeve. PCCI tested two IMS prototypes, one is nominally 2 meters long and the other is 4 meters. Each end has a padeye and 0.3m in diameter steel flange which acts as a fabric clamp and has threaded air ports. As the device extends, the diameter constricts, increasing the internal pressure. The load-extension curve for the device is non-linear, with greater stiffness at higher loads.

The IMS prototype units were bench-tested at a PCCI facility. Here, the devices were pressured to verify airtightness and were fit-checked with the air-fittings and shackles. Note, the 2m device is on the left, and 4m on the right.

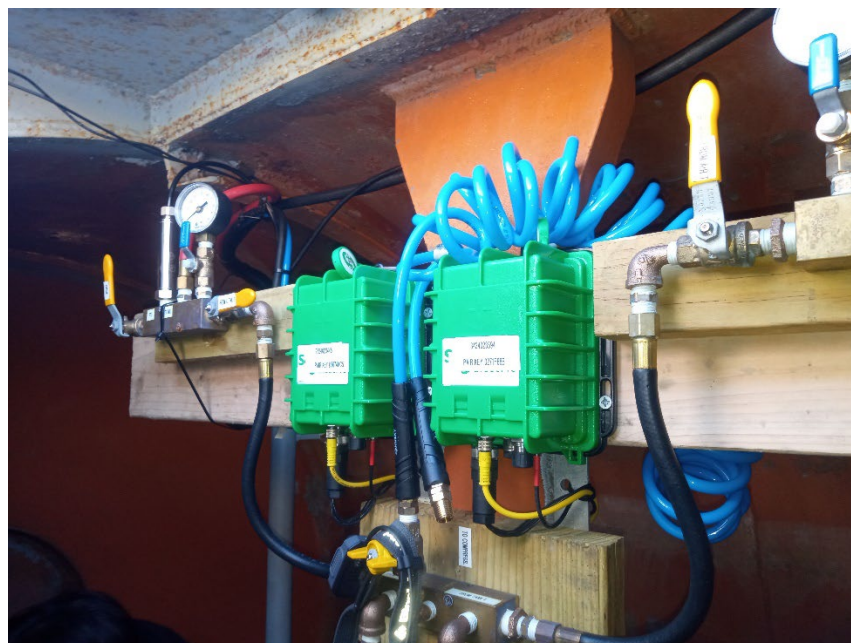
Figure 5. Inside Data Buoy: Data Acquisition and Air Systems

- Two independent Schneider Electric (Ayyeka) data acquisition units capable of storing and transmitting data over the wireless network. Each unit has its own loadshackle, pressure sensor, and battery bank.
- Two battery banks, each with five 12V 100Ah LiFePO4, marine batteries in parallel.
- Two 150 cubic foot steel air tanks.
- Aluminum hatch for accessing pressure control valves.
- 300-lbs of adjustable ballast weight.
- USCG approved navigation light and radar reflector.

Mounted inside the buoy are independent data acquisition, air, and electrical systems. The pressure sensors are internal and attach to 1/4inch air lines which run down to the IMS units. The loadshackles are mounted below the surface and transmit to the data buoy via 4-20 mA signal cables.

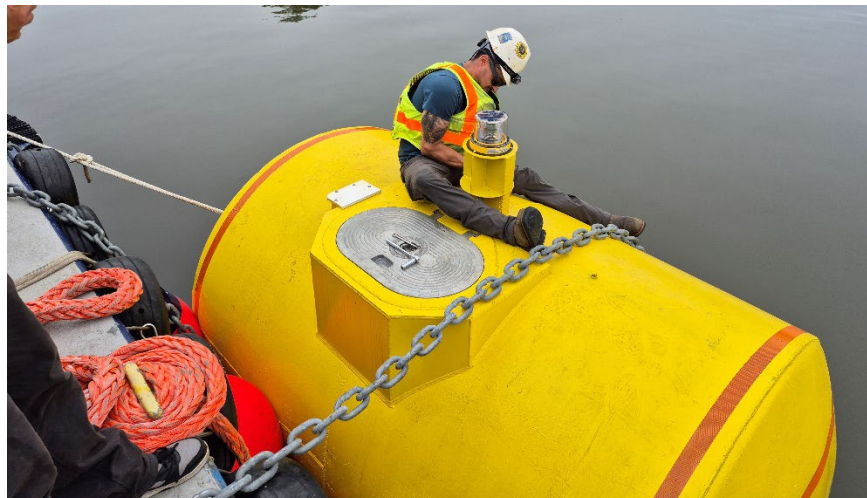
Figure 7. Floating Data Buoy

The data buoy is meant to ride on the surface to capture wave forces and to house the data acquisition, electrical, and air systems. The buoy was modified from a steel tension-bar mooring spring buoy and is 10-ft x 6-ft diameter. The weight of the buoy is 4800 lbs. fully loaded.

The hatch, light, and radar reflector are shown. The white panel is a plastic cover for a compartment containing cell network antennas.

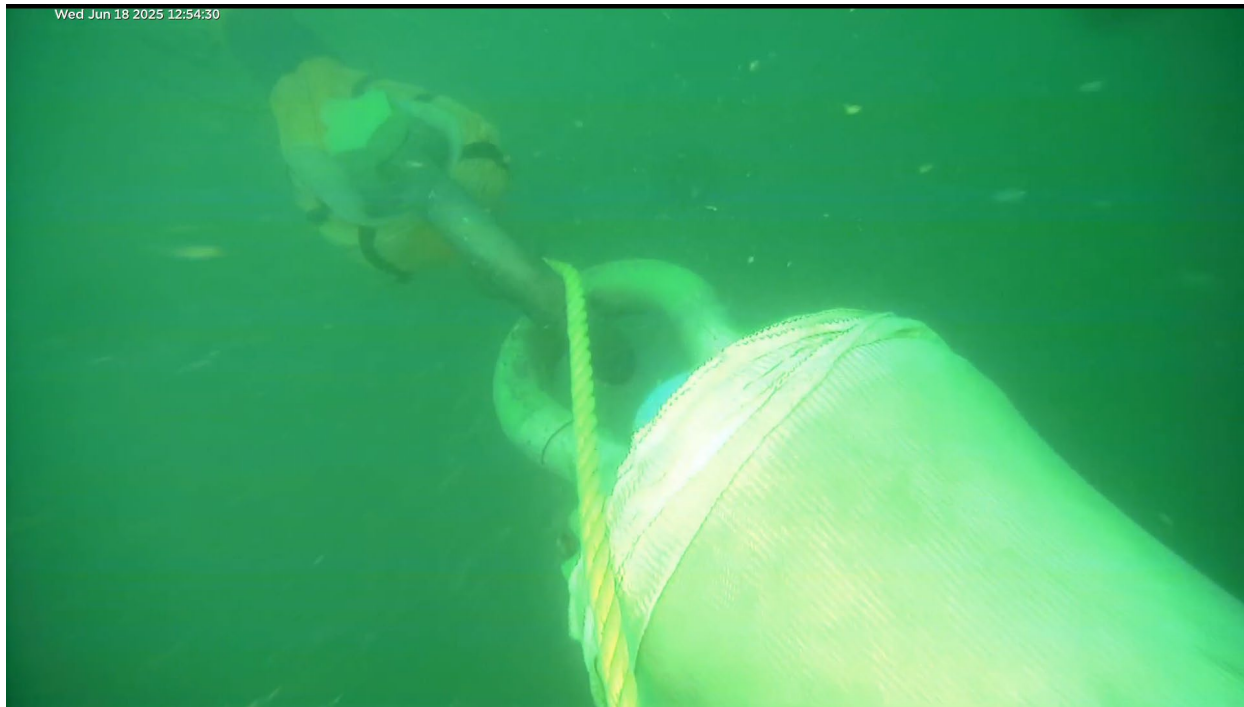
4m IMS end flange (without air connection) with 2" and 2" wide jaw shackles connected to 2.5" HMPE thimble.

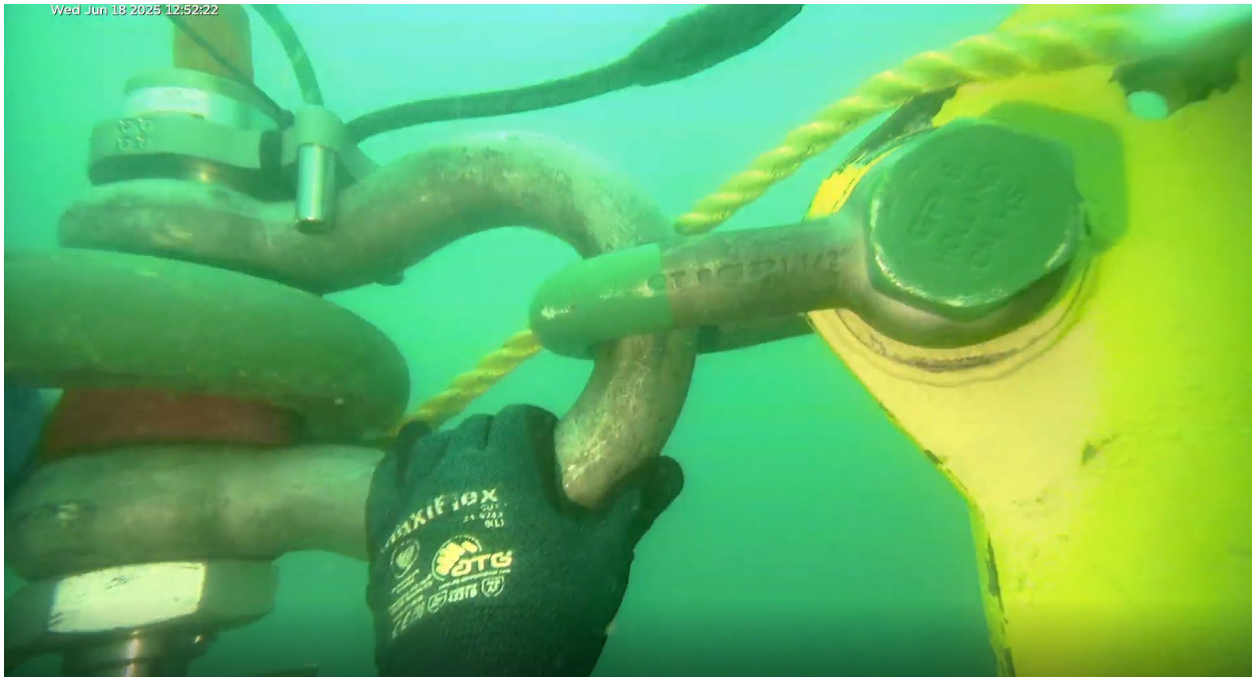
View of flounder plate on right, attached to a loadshackle, and the 4m IMS on the left.
