Technical Developments for the Inspection of Off-shore Wind Blades: Final Report

NOWRDC #126 Report Deliverables for 4.1

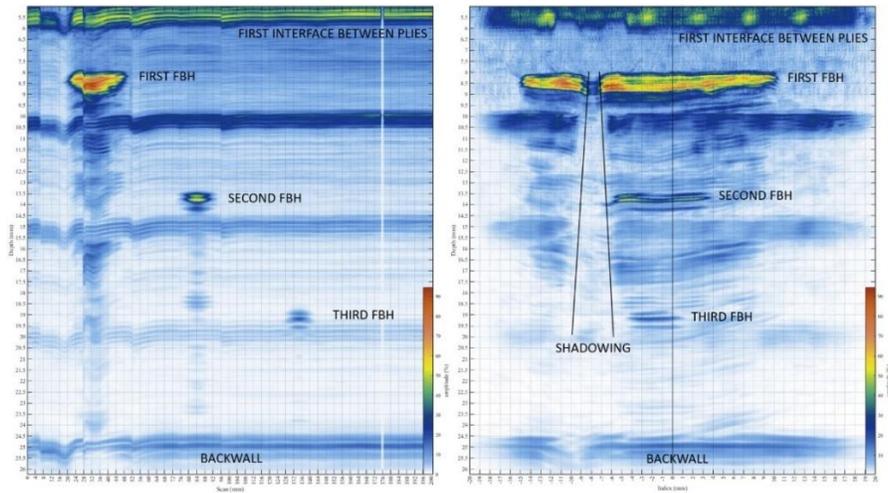
Figure 5-2. Cumulated side view (left subplot) and end view (right subplot) of the FMC/TFM scan of the TPI sample at 5MHz.

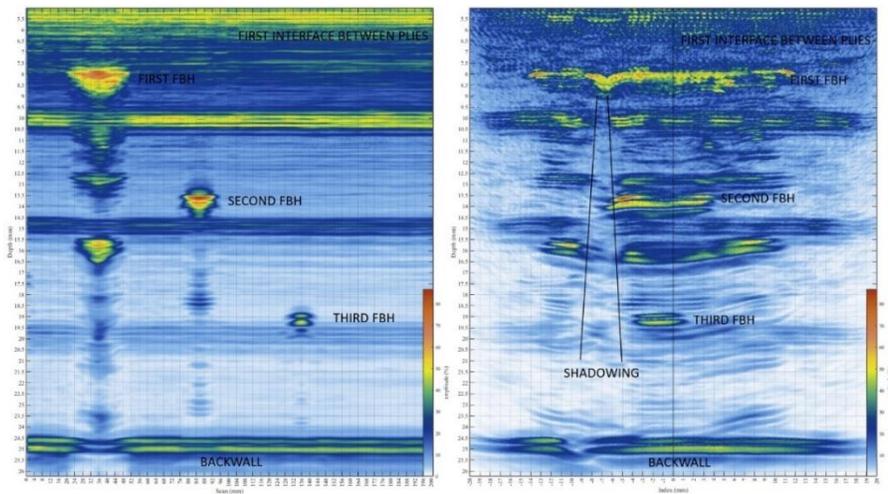
Figure 5-19. Cumulated side view (left subplot) and end view (right subplot) of the PWI/TFM scan of the TPI sample at 5MHz.

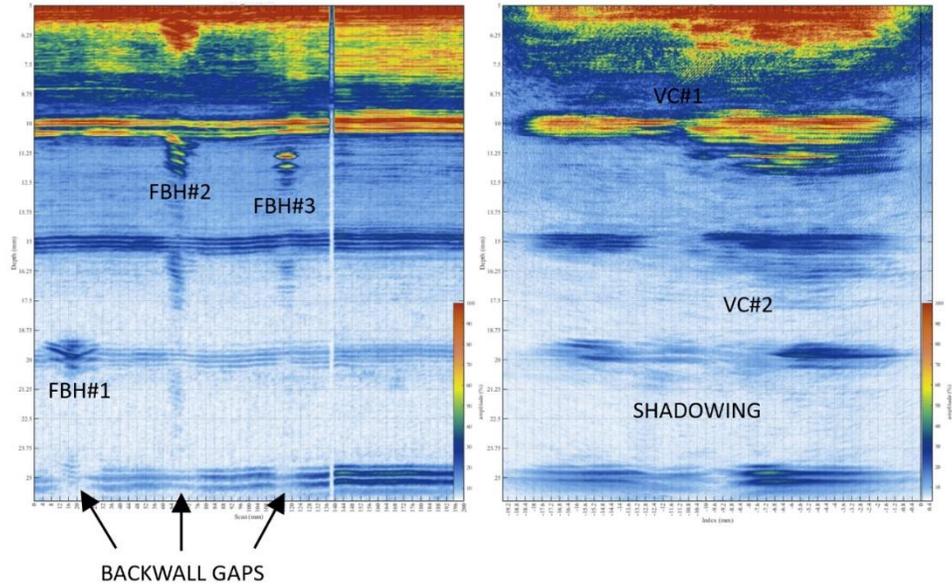
Figure 5-4. Cumulated side view (left subplot) and end view (right subplot) of the FMC/TFM scan of the TPI sample at 10MHz. The annotation lists void channels (VC) and flat-bottom holes (FBH).

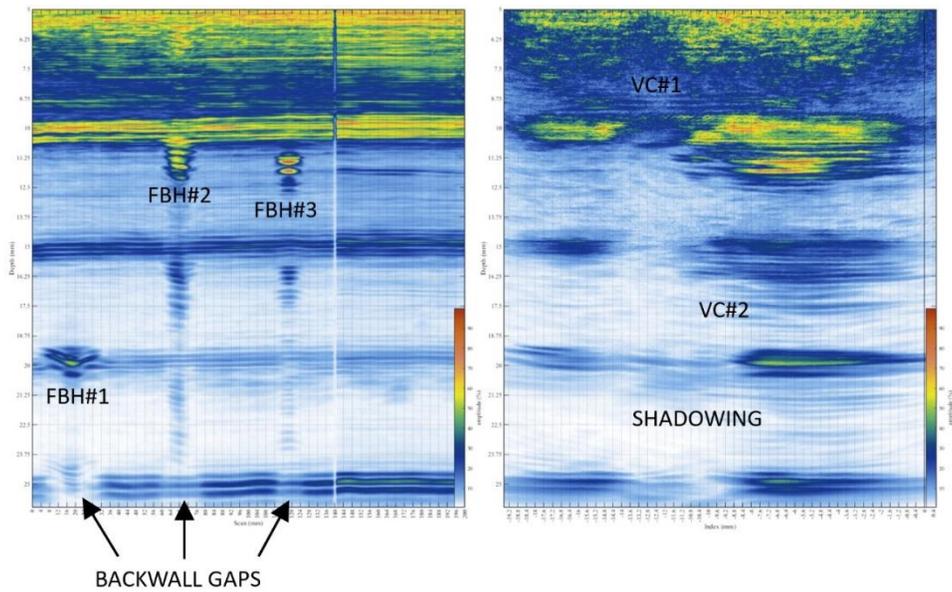
Figure 5-5. Cumulated side view (left subplot) and end view (right subplot) of the PWI/TFM scan of the TPI sample at 10 MHz. The annotation lists void channels (VC) and flat-bottom holes (FBH).

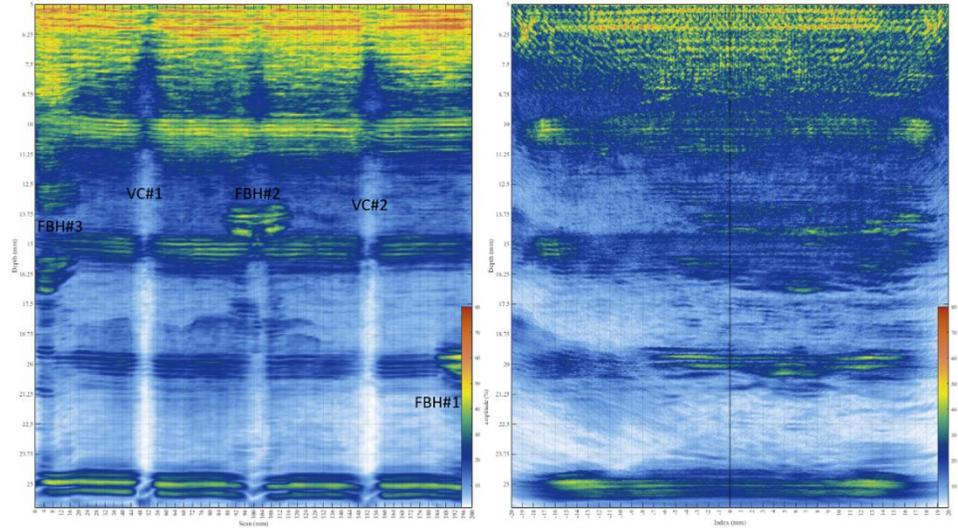
Figure 5-6. Cumulated side view (left subplot) and end view (right subplot) of the PWI/TFM scan of the TPI sample at 5MHz. Scan taken “transversely”; that is, with the probe motion aligned to the second-longest dimension of the plate. The annotation lists void channels (VC) and flat-bottom holes (FBH).

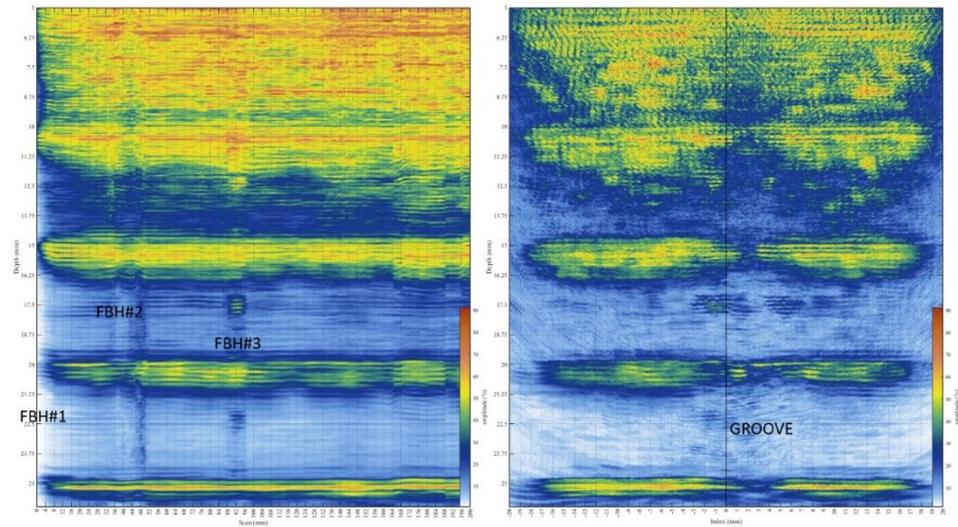
Figure 5-7. Cumulated side view (left subplot) and end view (right subplot) of the PWI/TFM scan of the TPI sample at 5MHz. Scan taken from the face connected to the FBHs.

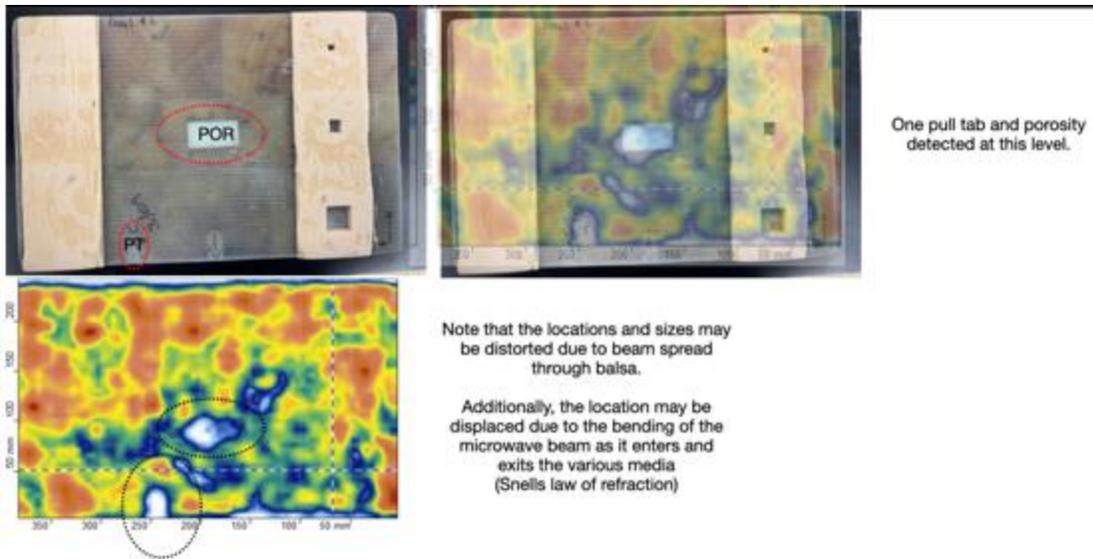
Figure 5-10 through 5-20 present the results of microwave testing on the balsa wood sample. Figure 5-10 shows the location of the simulated porosity and one of the pull-tabs as detected through the balsa core. Figure 5-11 demonstrates the detection of the ply drops in the GFRP layer through the balsa core. Figure 5-12 shows four additional pull-tabs which were detected through the balsa core. Finally, Figure 5-13 shows that two of the three bond paste flaws are detected though two GFRP layers and the balsa core. The smaller of the three instances of delamination in the bond paste was determined to possibly be detectable in the sensor data, but not necessarily reliably. In total, all flaws except the smallest bond paste flaw were detected.

Figure 5-10. Lower GFRP samples compared to flaw locations.

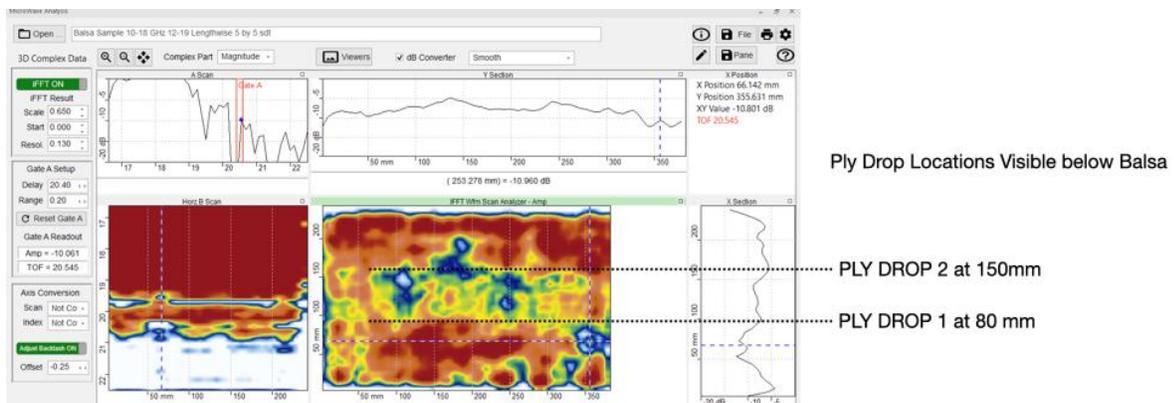
Figure 5-1120. Lower GFRP layer (1in.=25.4mm).

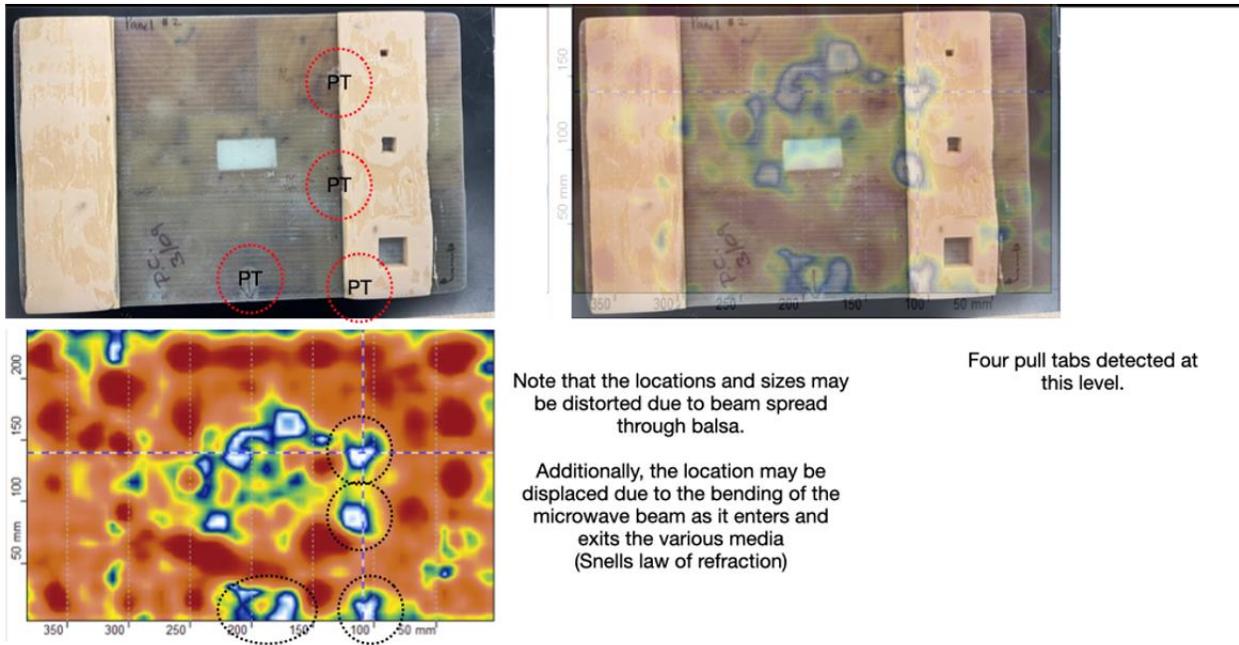
Figure 5-12. Lower GFRP layer compared to flaw locations.

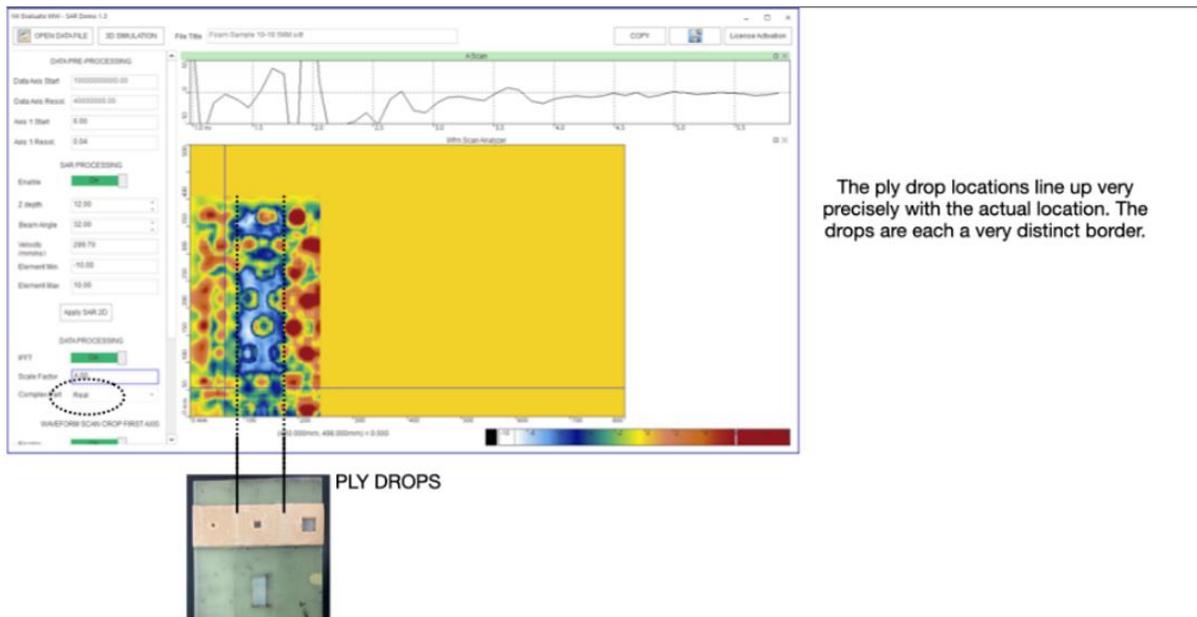
Figure 5-14 shows how the ply drops in the lower GFRP layer are detectable through the balsa core. The ply drop locations in the data are close to the actual ply drop locations, even with beam spread and attenuation through the foam core.

Figure 5-14. Ply Drop Detection.

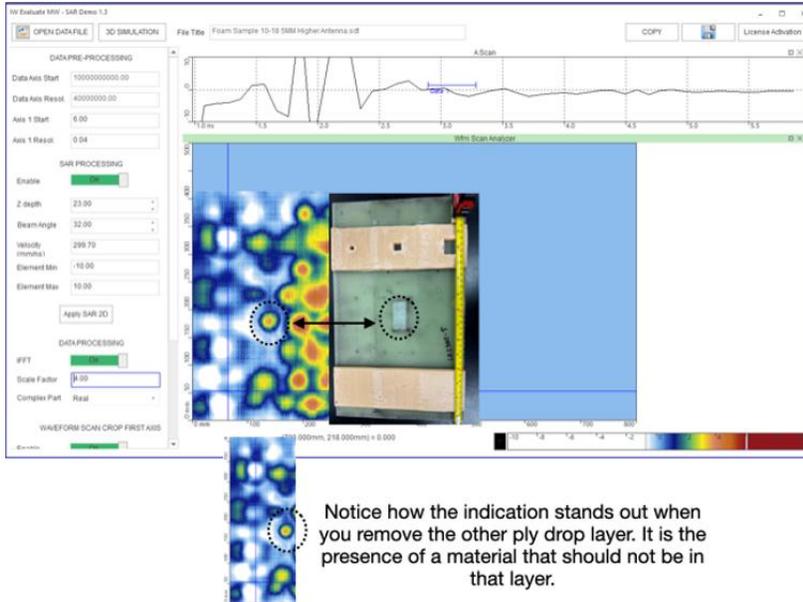
Figure 5-15 demonstrates how the porosity flaw is detectable in the presence of the resin hole background noise. The simulated porosity flaw results in a much different signal than the rest of the GFRP panel in which it is located. Figures 5-16, 5-17, and 5-18 show three of the pull-tab locations near the edge of the sample. Finally, Figure 5-19 shows all three bond paste flaws and the remaining two pull-tabs. This data analysis set indicates how all flaws are detectable though the foam core.

Figure 5-15. Porosity foam flaw.

The use of foam as substitute for porosity in a foam core sample is likely not the best approach.

The dielectric of both foams is similar enough that detection is difficult, but not impossible.

The indication would be that of a material in that GFRP layer that should not be present.

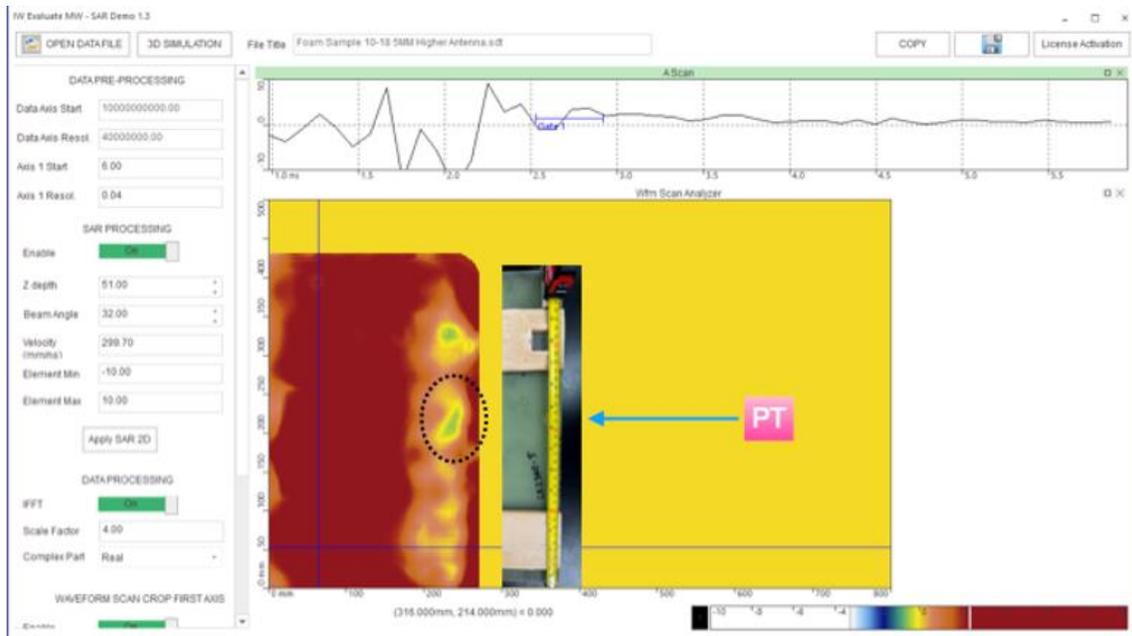
Figure 5-16. Pull-tab.

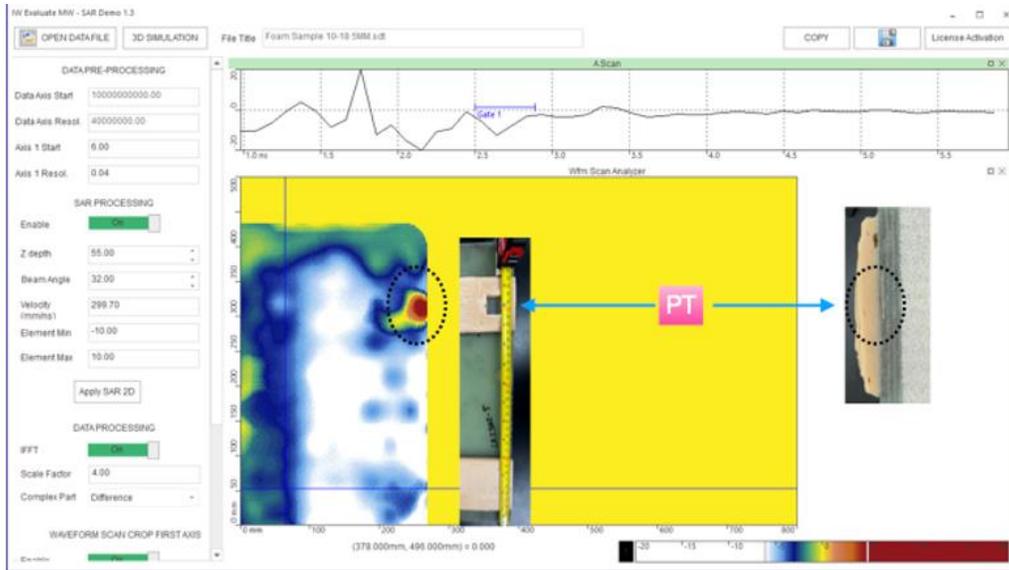
Figure 5-17. Pull-tab under bond paste.

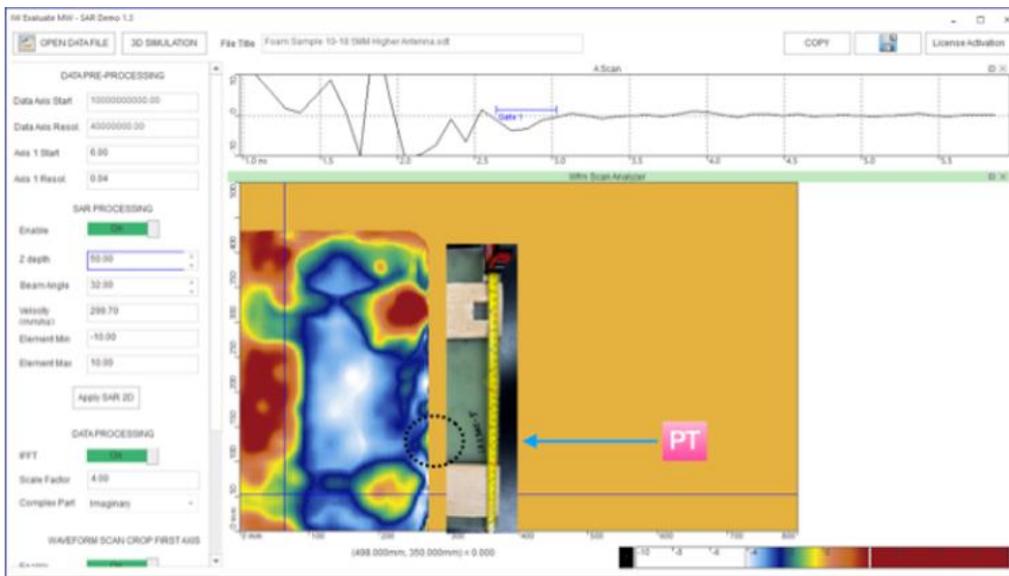
Figure 5-18. Pull-tab.

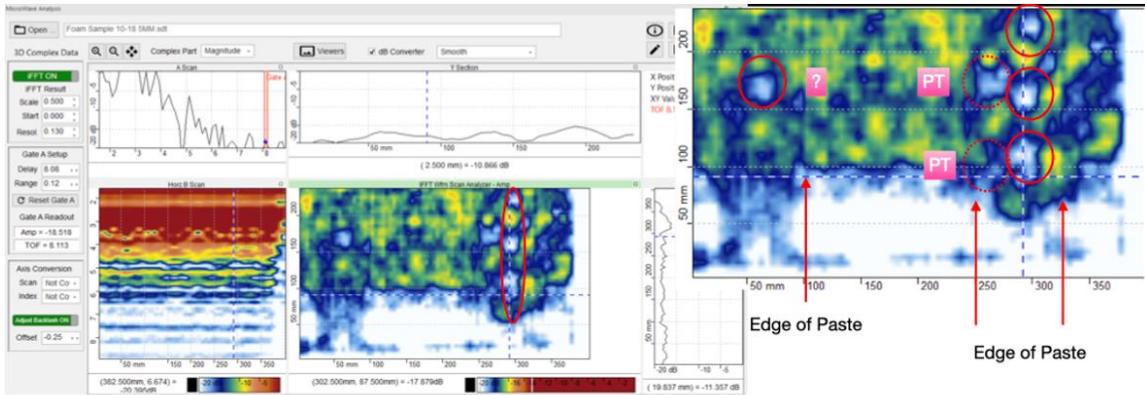
Figure 5-19. Bond paste flaws.

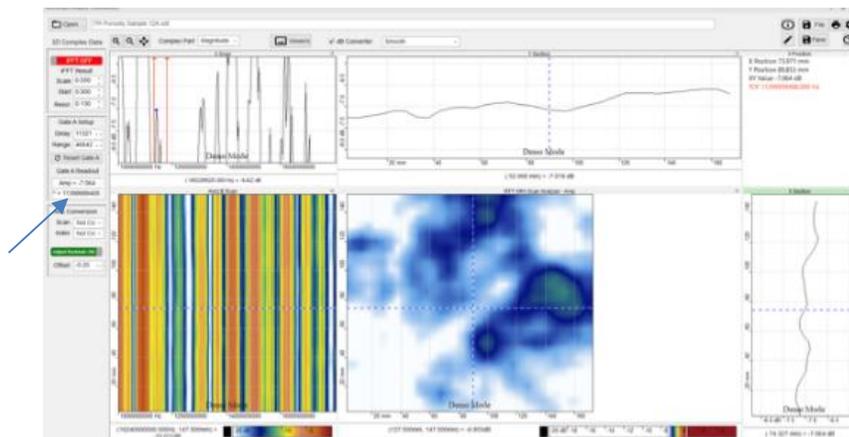
Note that Figure 5-20 is created from the same data that can be used for thickness evaluation and depth of defect analysis. If we use the depth approach in the IFFT mode, the image becomes more granular and porosity can be localized within the part. This approach would allow for detection of specific areas of porosity that might be remediated to restore the part strength capability. Specifically, the high porosity sample in Figure 5-21 shows what is likely a channel where air traveled from the edge to the center of the part. This hypothesis is consistent with how the porosity (air) was introduced into the panel during construction. The arrow in the image shows the likely air flow path. This demonstrates the ability to detect overall porosity along with normal part inspection.

Figure 5-21. Depth Image with Possible Air Path.

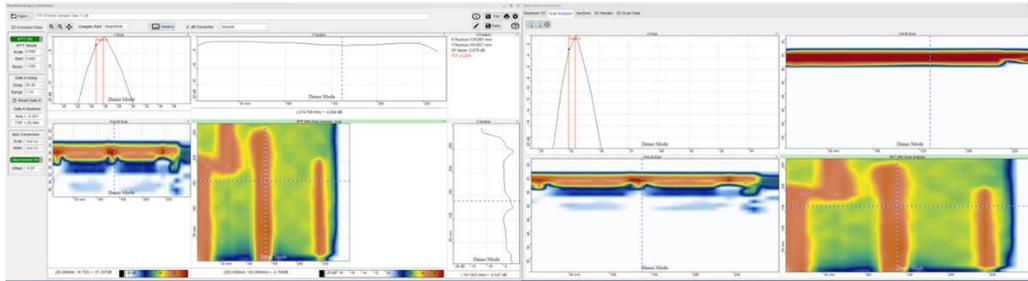
Figure 5-23 shows that detection of the wrinkle is simple and very clear. The wrinkle has a very distinctive shape in the B Horizontal image. This image is only possible because of the multi-frequency data collection and implementation of the IFFT for the data. This places the data in a “Time of Flight” mode, so the B Horizontal represents a cross section of the part. The signature shape for a wrinkle so distinctive that AI automated detection is possible for future iterations.

Figure 5-23. Wrinkle Panel Image.

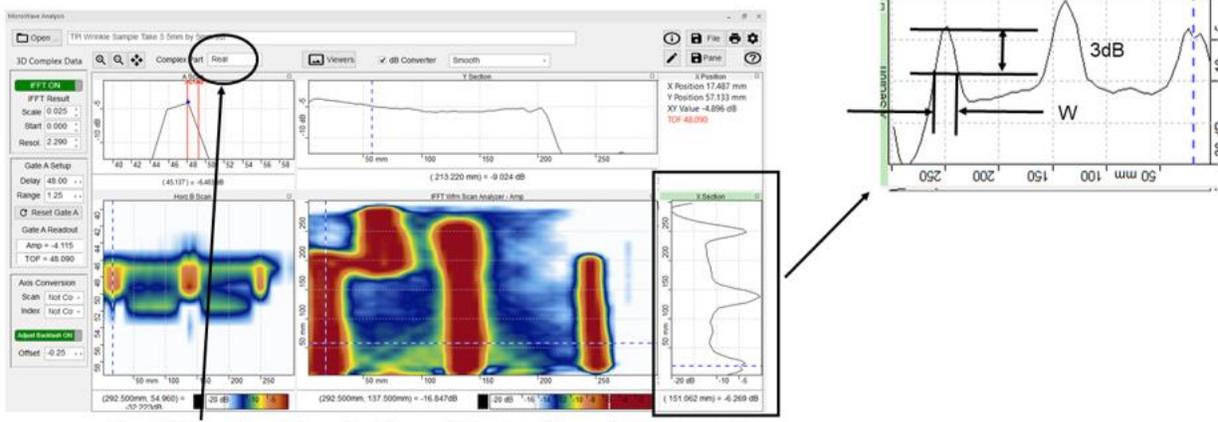
The wrinkle data appears as a peak in the data line that intersects the wrinkle. The width of the peak is measured at a location defined as 3dB below the peak. The width at that location is used as the defined width of the flaw. This is demonstrated in Figure 5-24.

The REAL portion of the reflection coefficient provides a better view of the neat resin layer.

Figure 5-24. Width Measurement.

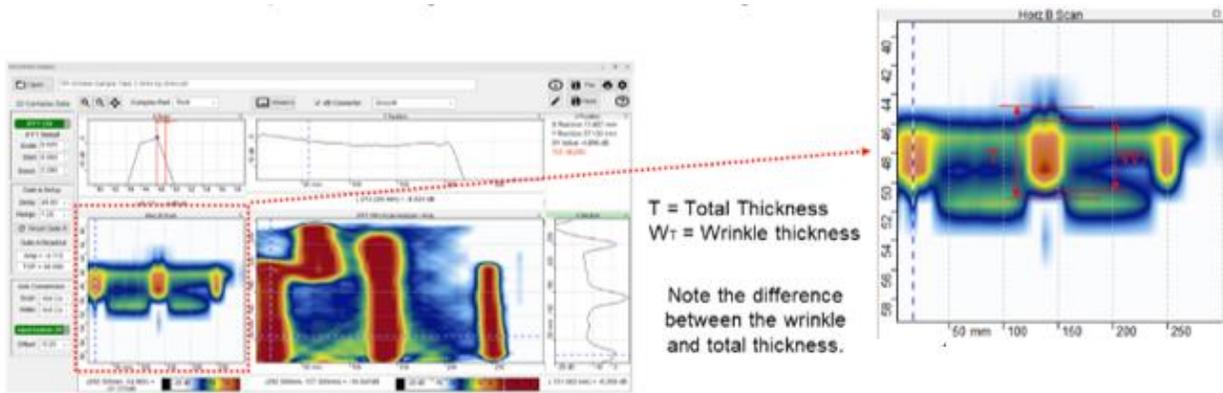
To accurately determine the wrinkle height, the material dielectric properties must be part of the input as the resolution factor. The dielectric properties determine the speed of light in the material, which determines the scale for the time of flight. The methods for determining the wrinkle width and depth were established using this sample. The results demonstrated that the method is capable of detecting wrinkles and measuring the critical dimensions of width and thickness of the wrinkles in GFRP. In this case, the material is GFRP and so the resolution is set to 2.290. When this value is used for resolution, the Y axis in the B horizontal closely approximates mm in GFRP. Thus, the height of the wrinkle can then be measured directly in the B Horizontal image.

Figure 5-25. Wrinkle height.

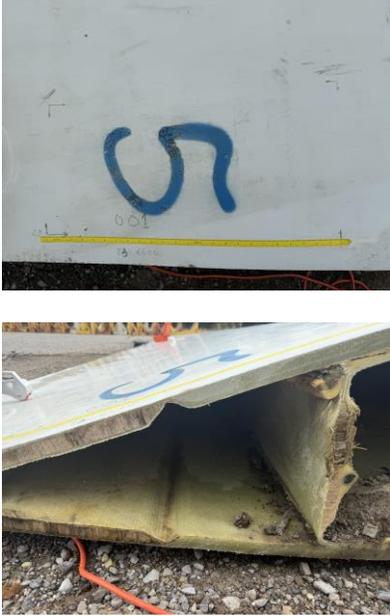
Section #	Approx. Section Location on Blade	Material(s)	Flaw as defined by EPRI's Blade Anomaly Dictionary	Photo(s)
1	Outboard 33%	Fiberglass, balsa wood, gel coat	Delamination, bond anomalies

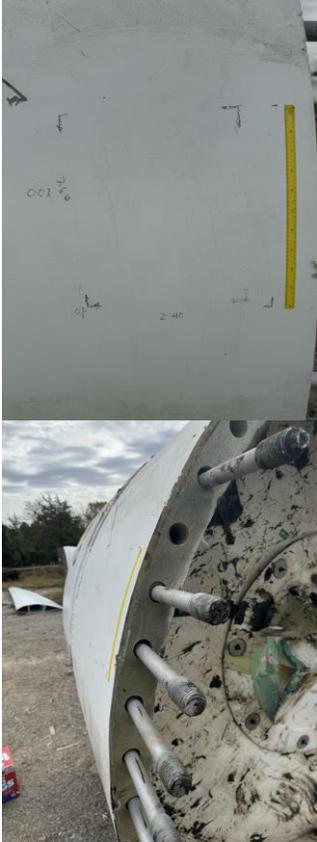
<p>2</p>	<p>Root</p>	<p>Steel, bolt inserts, bolts, fiberglass, gel coat</p>	<p>Root insert gaps, root laminate delamination</p>

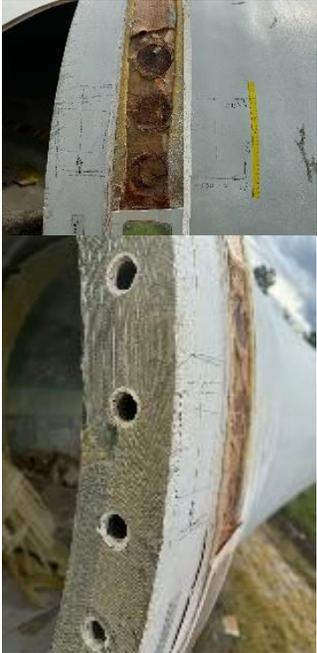
<p>3</p>	<p>Root</p>	<p>Steel, bolt inserts, bolt shroud fabric, fiberglass, gel coat</p>	<p>Root insert gaps, root laminate delamination</p>

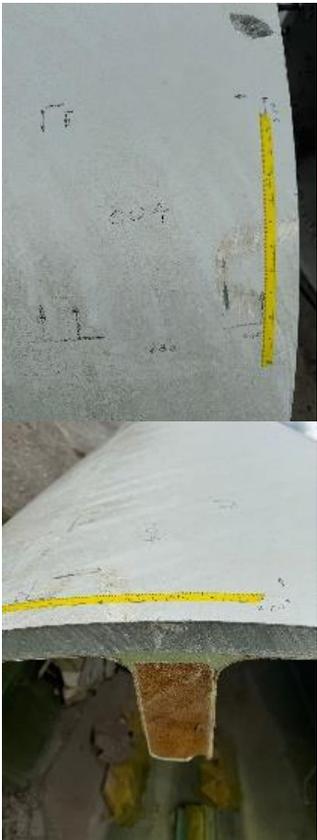
<p>4</p>	<p>Midboard 33%</p>	<p>Fiberglass, foam core, adhesive gel coat</p>	<p>Internal blade reinforcements, surface gouges</p>

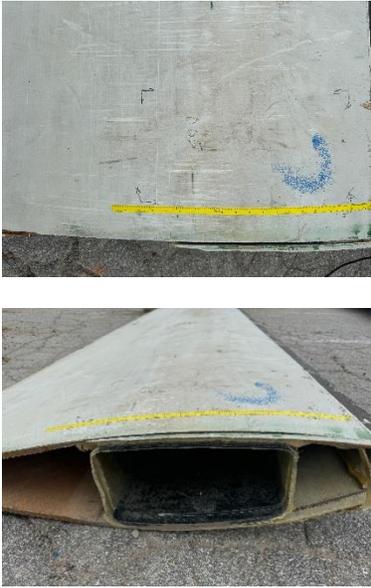
<p>5</p>	<p>Outboard 33%</p>	<p>Fiberglass, balsa wood, adhesive woven carbon fiber, gel coat</p>	<p>Fiber wrinkles, bond anomalies, delamination</p>

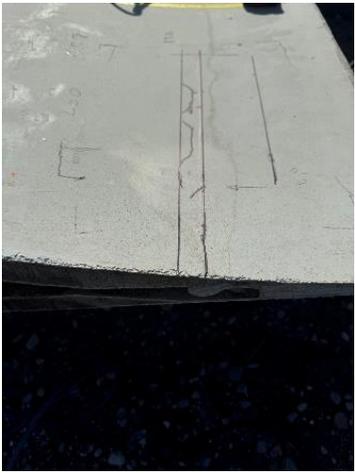
<p>6</p>	<p>Outboard 33%</p>	<p>Fiberglass, balsa wood, gel coat, adhesive</p>	<p>Bond anomalies, end of bond line bead, bond line thickness</p>

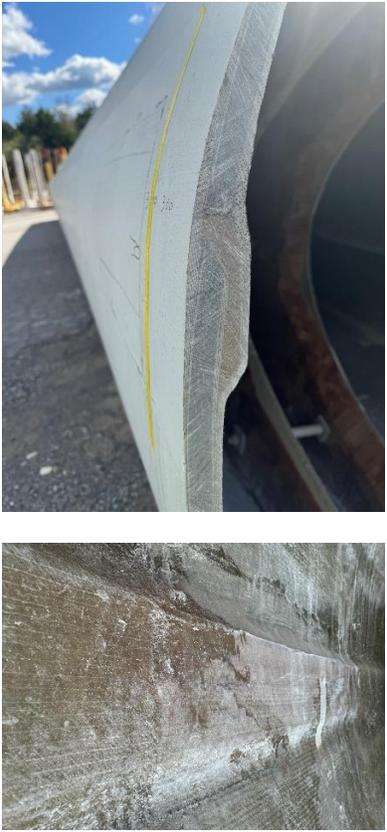
<p>7</p>	<p>Root composite</p>	<p>Fiberglass, balsa wood, gel coat, repair patches</p>	<p>Single shot blade geometry, factory repairs</p>

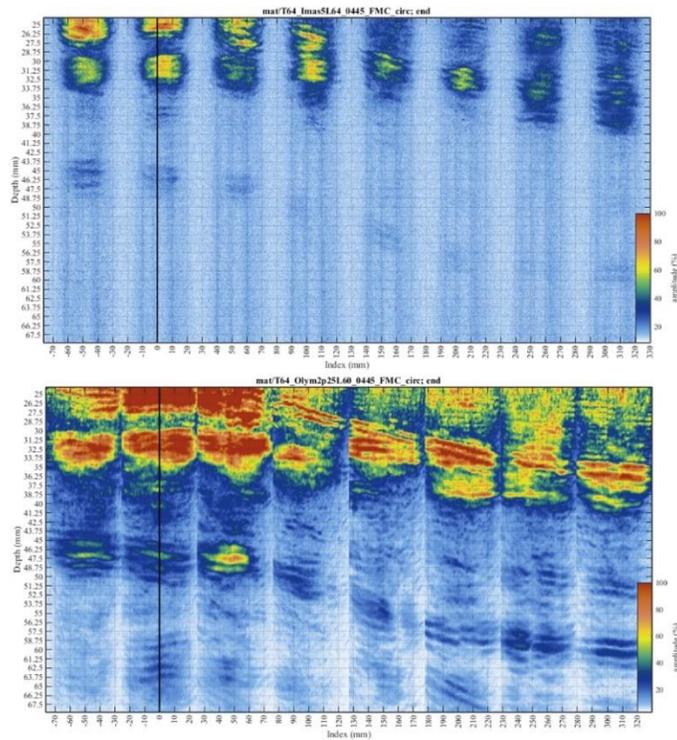
Figure 7-8. End view of Section #7 composited from volumetric UT data acquired by (a) the Imasonic 5MHz probe and (b) the Olympus 2.25MHz probe

Just as in the case of Section #4, the internal structure is not consistent with depth (or index position, in the context of these UT scans). Observing the side views at different scan indices illustrates these changes. We also see evidence of this from the composited end view, shown in Figure 7-8.

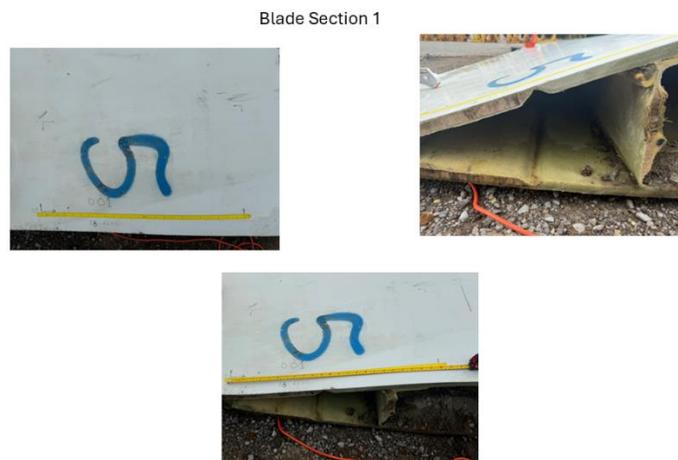
Figure 7-22. Image of inspection zone

Blade Section #1 was inspected using the MAPS system to assess its internal and external structural integrity. Microwave imaging was used to identify anomalies such as bonding issues, delamination, embedded wrinkles, or voids.

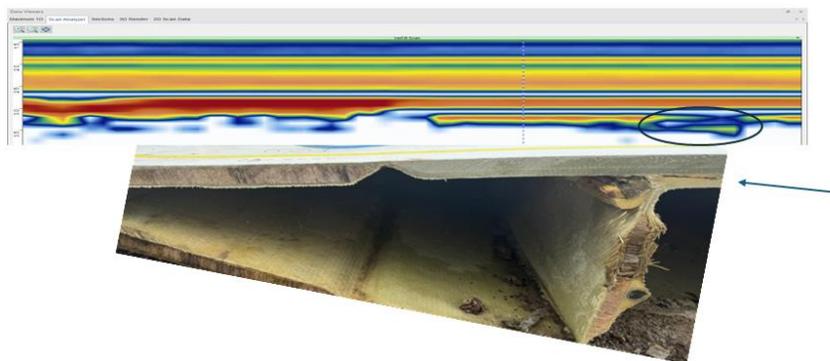
Figure 7-24. Inspection cross section using Horizontal B identifying delamination at spar cap

Advanced microwave imaging provided clear visualization of defects within this section. The identified flaw types—such as disbonds and bond paste errors demonstrate the system’s ability to detect and spatially resolve flaws through layered materials and bonding interfaces. These insights are crucial for evaluating both manufacturing consistency and in-service degradation.

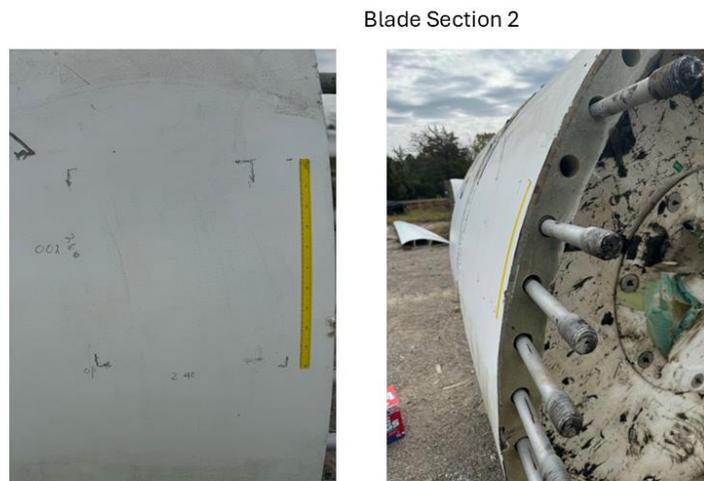
Figure 7-253. Inspection Site 2 – Blade Root

1. Stud locations and barrel nut identified
2. One rounded void indication was identified between two studs

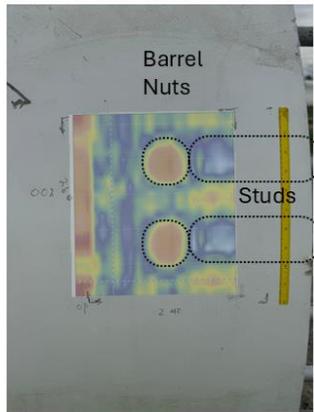
Note that the “stud” indication appears oblong in both images, but more so on the lower stud. This is due to a downward shift in stud location.

Figure 7-264. Root Top view and cross section showing construction detail

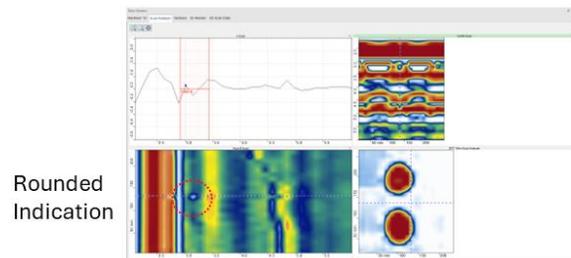
Figure 7-275. Inspection Images with rounded indication mid stud

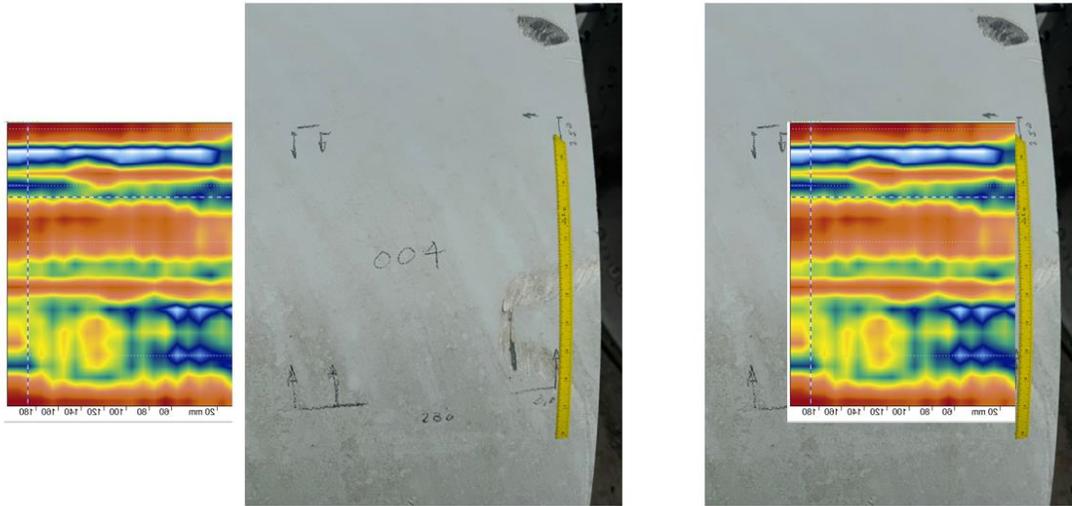
Figure 7-310. Inspection image in plain view

1. Delamination at GFRP to bond paste in several regions of the spar to blade tapered bond paste.
2. No other indications identified

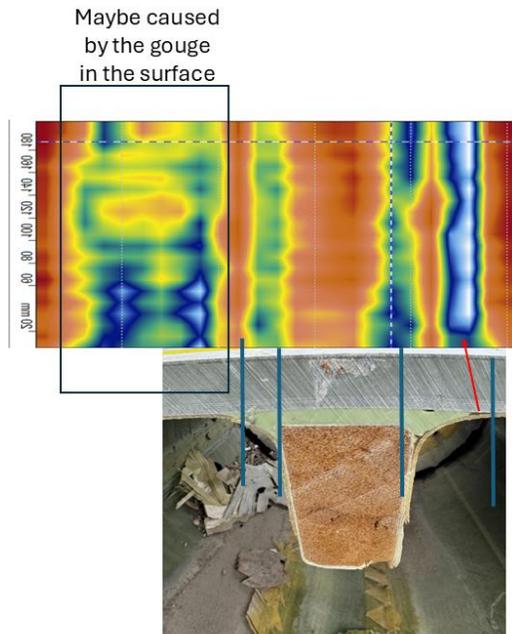
Figure 7-321. Microwave inspection showing detection of flaws in bond paste levels

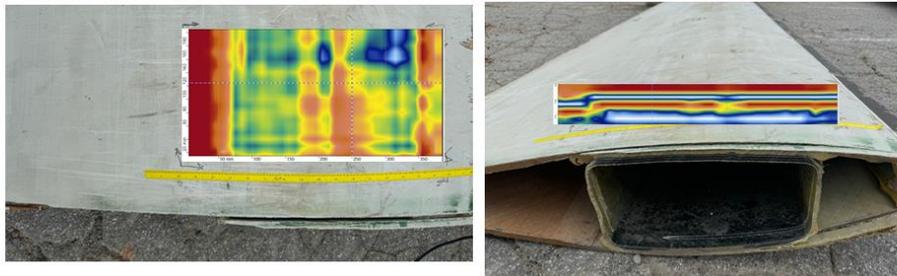
Figure 7-34. Plan and section detail of microwave inspection

1. Wrinkle – Wrinkle in CFRP spar cap identified.
2. Edges of CFRP Spar located.
3. Two bond line (CFRP Spar to GFRP) located and detected.

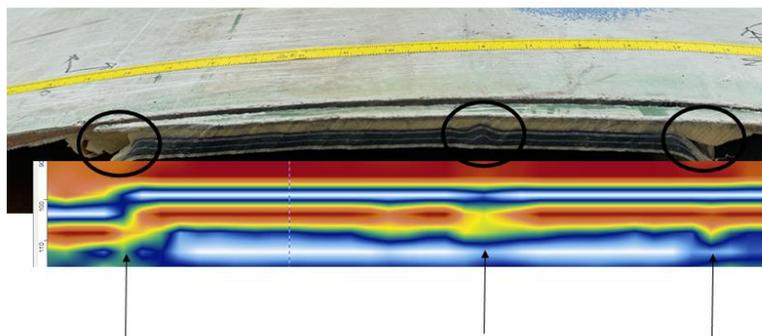
Horizontal B Section identifies the edges of the CFRP spar as well as the wrinkle in the CFRP

Figure 7-35. Close up comparison of Horizontal B image and blade cross section

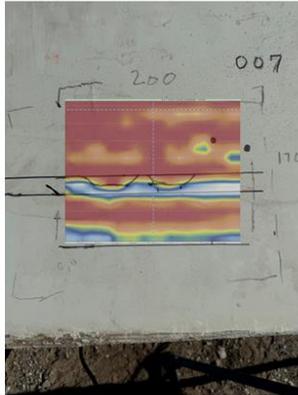
1. Detect and locate edge of bond paste from OD or ID.
2. Identified areas where bond paste did not migrate during application (i.e. – squeeze) leaving an area without paste.
3. Insufficient bond paste squeeze may result in an insufficiently bonded part.

C scan overlay on part shows approximately the same shape as the “drawn in” bond paste shape

Figure 7-38. Microwave C scan at depth shows ability to map edge of bond paste to validate proper squeeze out

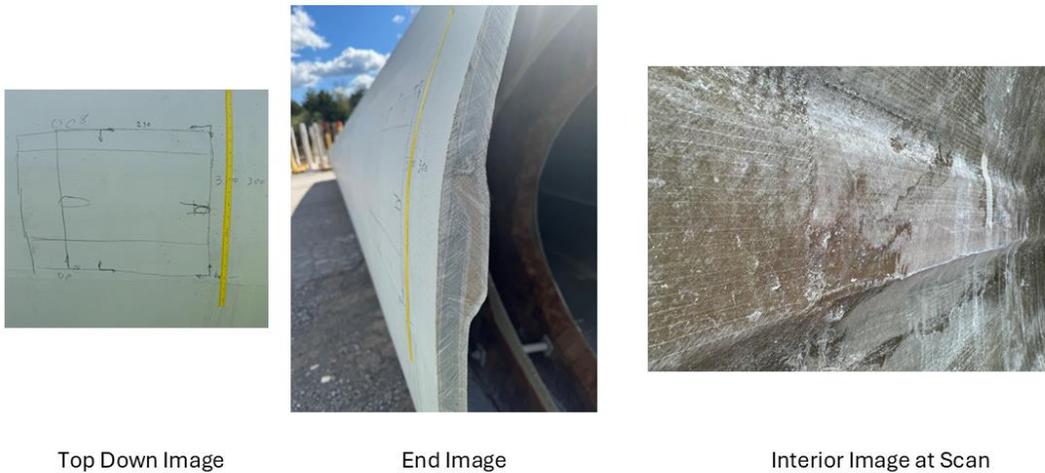
Figure 7-39. Edge of blade repair section

1. Stacked delamination (multiple delamination in same XY location but differing Z location) in repair.
2. Able to track ID thickness changes using Horizontal B (time of flight) data.
